# Asbestos Reinspection Survey

FX0001319  
Port of Workington Complex  
CA14 2JH

| Type of survey: | Reinspection Survey (MA and PA) + Management options | | |

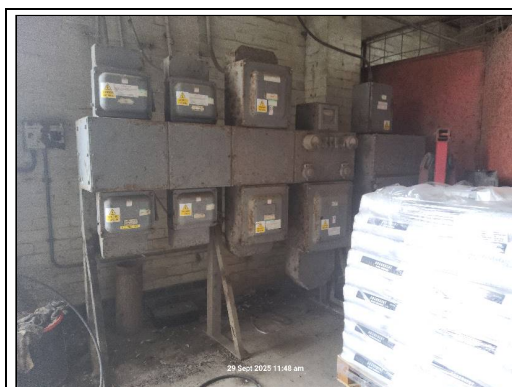
| Re-inspection Date: | Lead Surveyor | Survey Type | Floor | Analysis |
|---|---|---|---|---|
| 29 Sep 2025 to 4 Oct 2025 | Tony Alcock | Reinspection Survey | Ground Floor | Chrysotile (1) |
| P | Asbestos Textiles/Paper (2) | Unsealed (2) | Low Damage (1) | Usually inaccessible or unlikely to be disturbed (0) |

| Normal Occupancy | Score | Likelihood of disturbance | Score | Exposure Potential | Score | Maintenance Activity | Score |
|---|---|---|---|---|---|---|---|
| Recommendation | Manage and re-inspect | | | | | | |

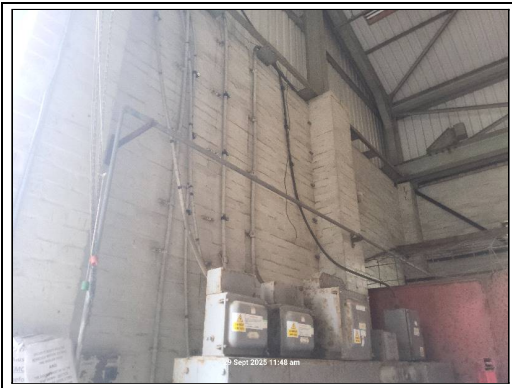
| | 29 Sep 2025 to 4 Oct 2025 | | Tony Alcock | Reinspection Survey | Ground Floor | Chrysotile (1) | |
| | P | | Reinforced Composite (1) | Completely Sealed (0) | Low Damage (1) | Usually inaccessible or unlikely to be disturbed (0) | |

| Recommendation | Manage and re-inspect | | | | | | |

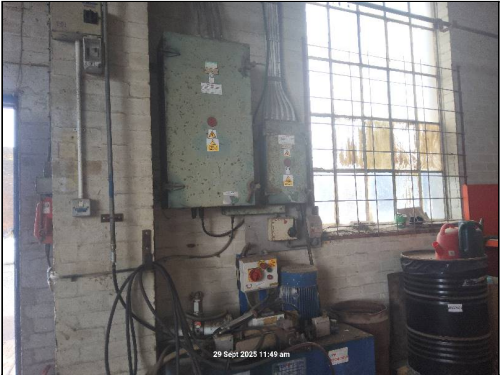
| | 29 Sep 2025 to 4 Oct 2025 | Tony Alcock | Reinspection Survey | Ground Floor | Chrysotile (1) |
| | P | Asbestos Textiles/Paper (2) | Unsealed (2) | Low Damage (1) | Usually inaccessible or unlikely to be disturbed (0) |

| <b>Recommendation</b> | Manage and re-inspect | | | | | | |

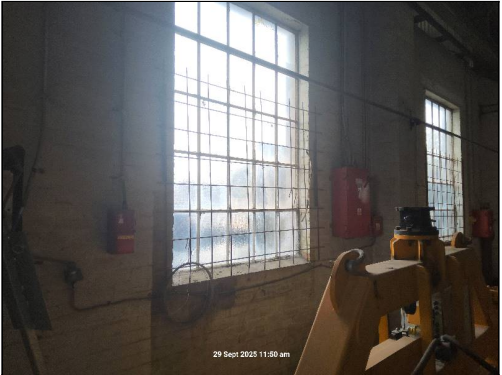
| | 29 Sep 2025 to 4 Oct 2025 | Tony Alcock | Reinspection Survey | Ground Floor | Chrysotile (1) |
| | P | Asbestos Textiles/Paper (2) | Unsealed (2) | Low Damage (1) | Usually inaccessible or unlikely to be disturbed (0) |

| <b>Recommendation</b> | Manage and re-inspect | | | | | | |

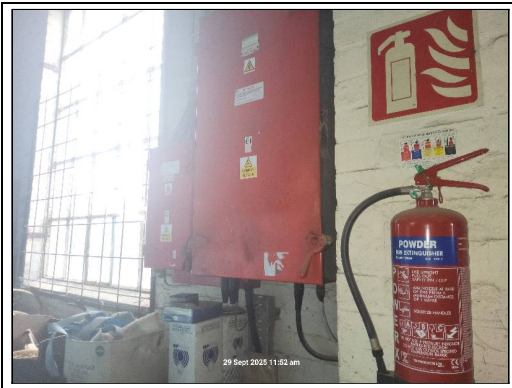
| | 29 Sep 2025 to 4 Oct 2025 | | Tony Alcock | Reinspection Survey | Ground Floor | Chrysotile (1) | |
| | P | | Asbestos Textiles/Paper (2) | Unsealed (2) | Low Damage (1) | Usually inaccessible or unlikely to be disturbed (0) | |
| <b>Recommendation</b> | Manage and re-inspect | | | | | | |

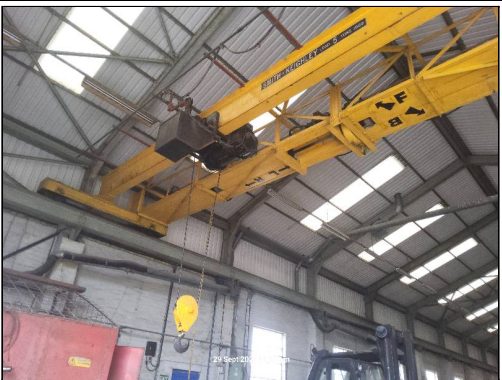
| | 29 Sep 2025 to 4 Oct 2025 | Tony Alcock | Reinspection Survey | Ground Floor | Chrysotile (1) |
| | P | Asbestos Textiles/Paper (2) | Unsealed (2) | Low Damage (1) | Usually inaccessible or unlikely to be disturbed (0) |

| <b>Recommendation</b> | Manage and re-inspect | | | | | | |

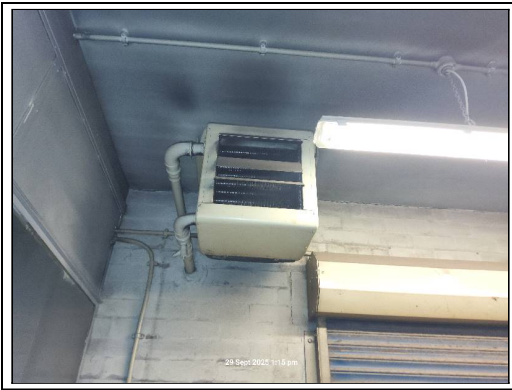
| | 29 Sep 2025 to 4 Oct 2025 | Tony Alcock | Reinspection Survey | Ground Floor | Chrysotile (1) |
| | P | Asbestos Textiles/Paper (2) | Unsealed (2) | Low Damage (1) | Usually inaccessible or unlikely to be disturbed (0) |

| <b>Recommendation</b> | Manage and re-inspect | | | | | | |

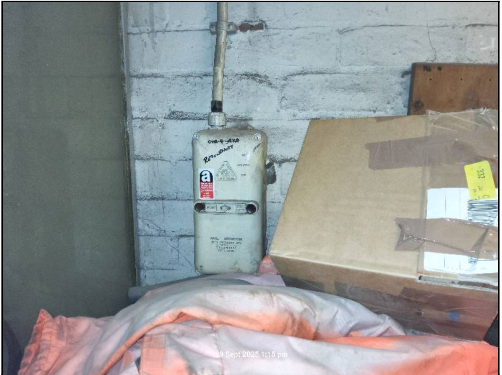
| | 29 Sep 2025 to 4 Oct 2025 | Tony Alcock | Reinspection Survey | Ground Floor | Chrysotile (1) |
| | P | Asbestos Textiles/Paper (2) | Unsealed (2) | Low Damage (1) | Usually inaccessible or unlikely to be disturbed (0) |

| <b>Recommendation</b> | Manage and re-inspect | | | | | | |

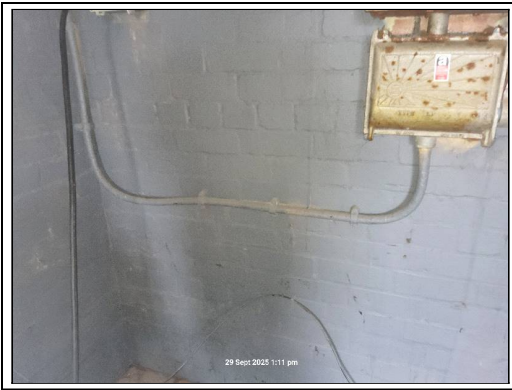
| | 29 Sep 2025 to 4 Oct 2025 | Tony Alcock | Reinspection Survey | Ground Floor | Chrysotile (1) |
| | P | Reinforced Composite (1) | Completely Sealed (0) | Low Damage (1) | Usually inaccessible or unlikely to be disturbed (0) |

| Recommendation | Manage and re-inspect | | | | | | |

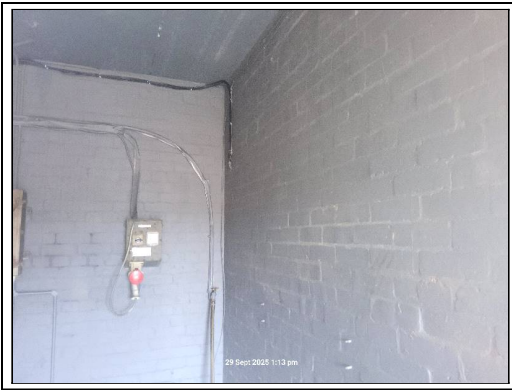
| | 29 Sep 2025 to 4 Oct 2025 | Tony Alcock | Reinspection Survey | Ground Floor | Chrysotile + Amosite (2) |
| | S AI002318 | Asbestos Insulation/Coating (3) | Surface Sealed (1) | High Damage (3) | Usually inaccessible or unlikely to be disturbed (0) |

| Recommendation | Manage and re-inspect | | | | | | |

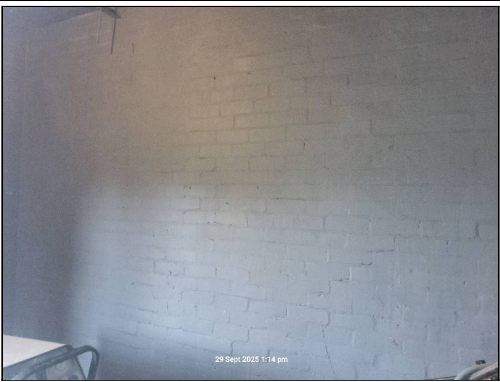
| | 29 Sep 2025 to 4 Oct 2025 | Tony Alcock | Reinspection Survey | Ground Floor | Chrysotile + Amosite (2) |
| | S<br>AI002320 | Asbestos Insulation/Coating (3) | Surface Sealed (1) | High Damage (3) | Usually inaccessible or unlikely to be disturbed (0) |

| <b>Recommendation</b> | Manage and re-inspect | | | | | | |

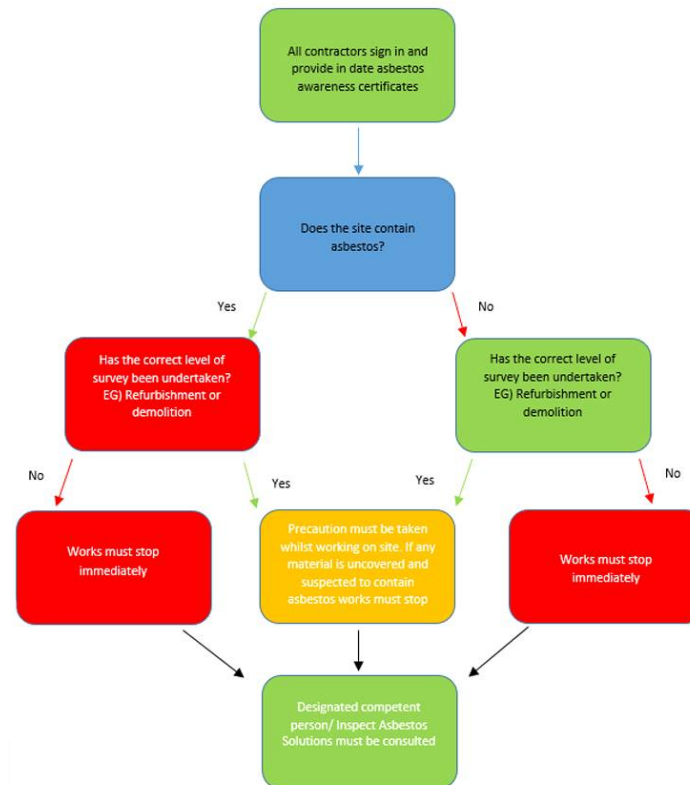
## 4. Contractor/Staff Management

The flow charts below apply to all persons undertaking works within the site

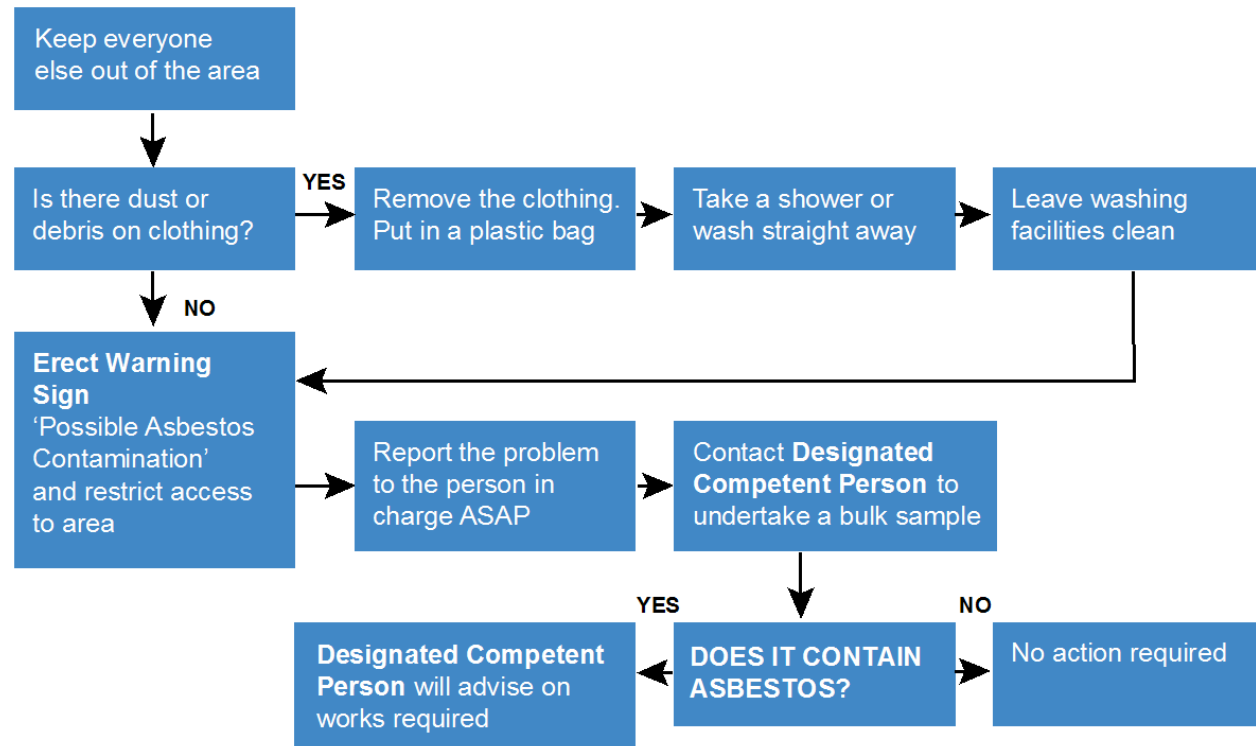
Although planned works can be managed, it is important to know what to do in the event that an asbestos bearing material is discovered or damaged

Below is a simple emergency procedure to follow:
